Lots 100, 101, 102 and 104 DP 1237882, Marsh Road, Warradale Road & Government Road SILVERDALE.

Eco Logical Australia Pty Ltd (ELA) was engaged by TRN Group to supervise the clearance undertaken as a part of the subdivision adjacent to Warradale Rd, Silverdale Rd and Government Rd, Silverdale. Supervision of clearance was required under the Wollondilly Shire Council development consent conditions (010.2014.00000675.001) and the associated Construction Environmental Management Plan (CEMP; report no. H180518 RP1).

Attachment 1: Reporting of supervised clearance at Lots 100, 101, 102 and 104 DP 1237882, Marsh Road, Warradale Road & Government Road SILVERDALE.

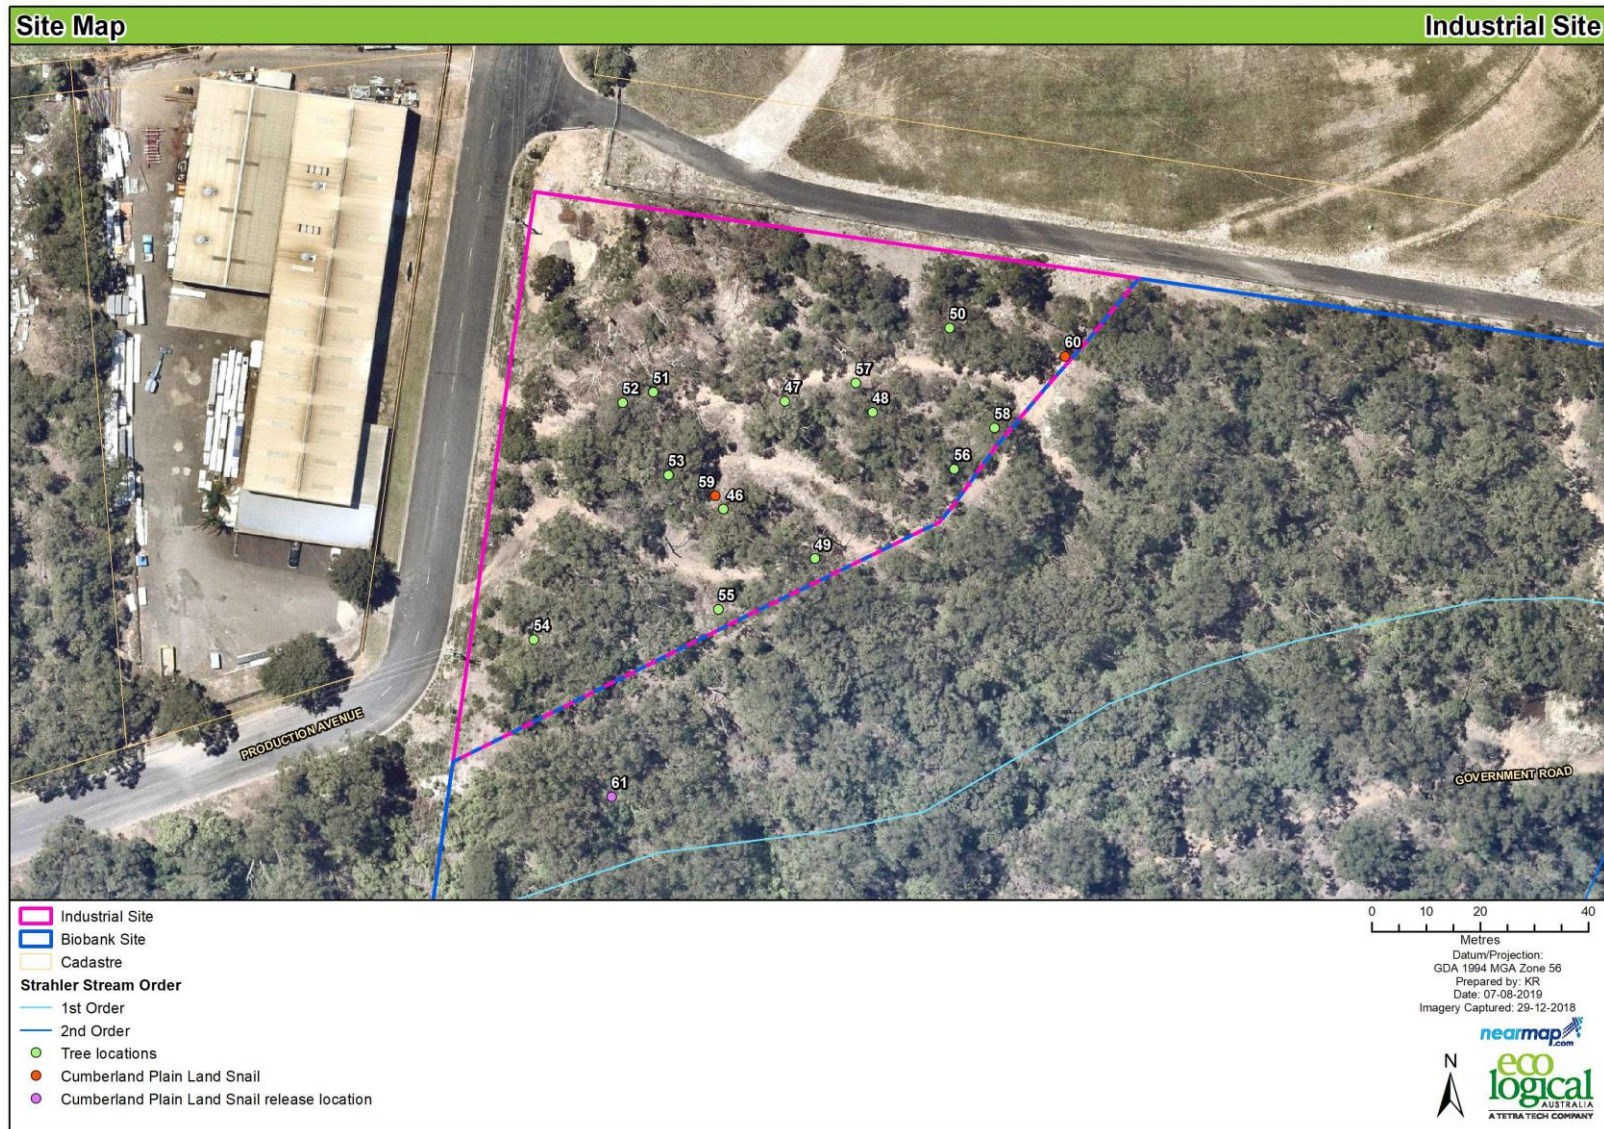
Figure 4 - Industrial Site

The location of habitat trees and habitat features inspected are shown in figures 1 to 4.

One Cumberland Plain Land Snail shell was found in the future subdivision site (Figure 4 & 5) under a large fallen tree that could not be moved during the pre-clearance works. The shell was moved into the BioBank site. No live CPLS individuals or any other evidence of the presence of CPLS were found during the clearance works.
